Treatment of PCB Contaminated Caulking Using AMTS

NASA Kennedy Space Center

University of Central Florida Orlando, FL

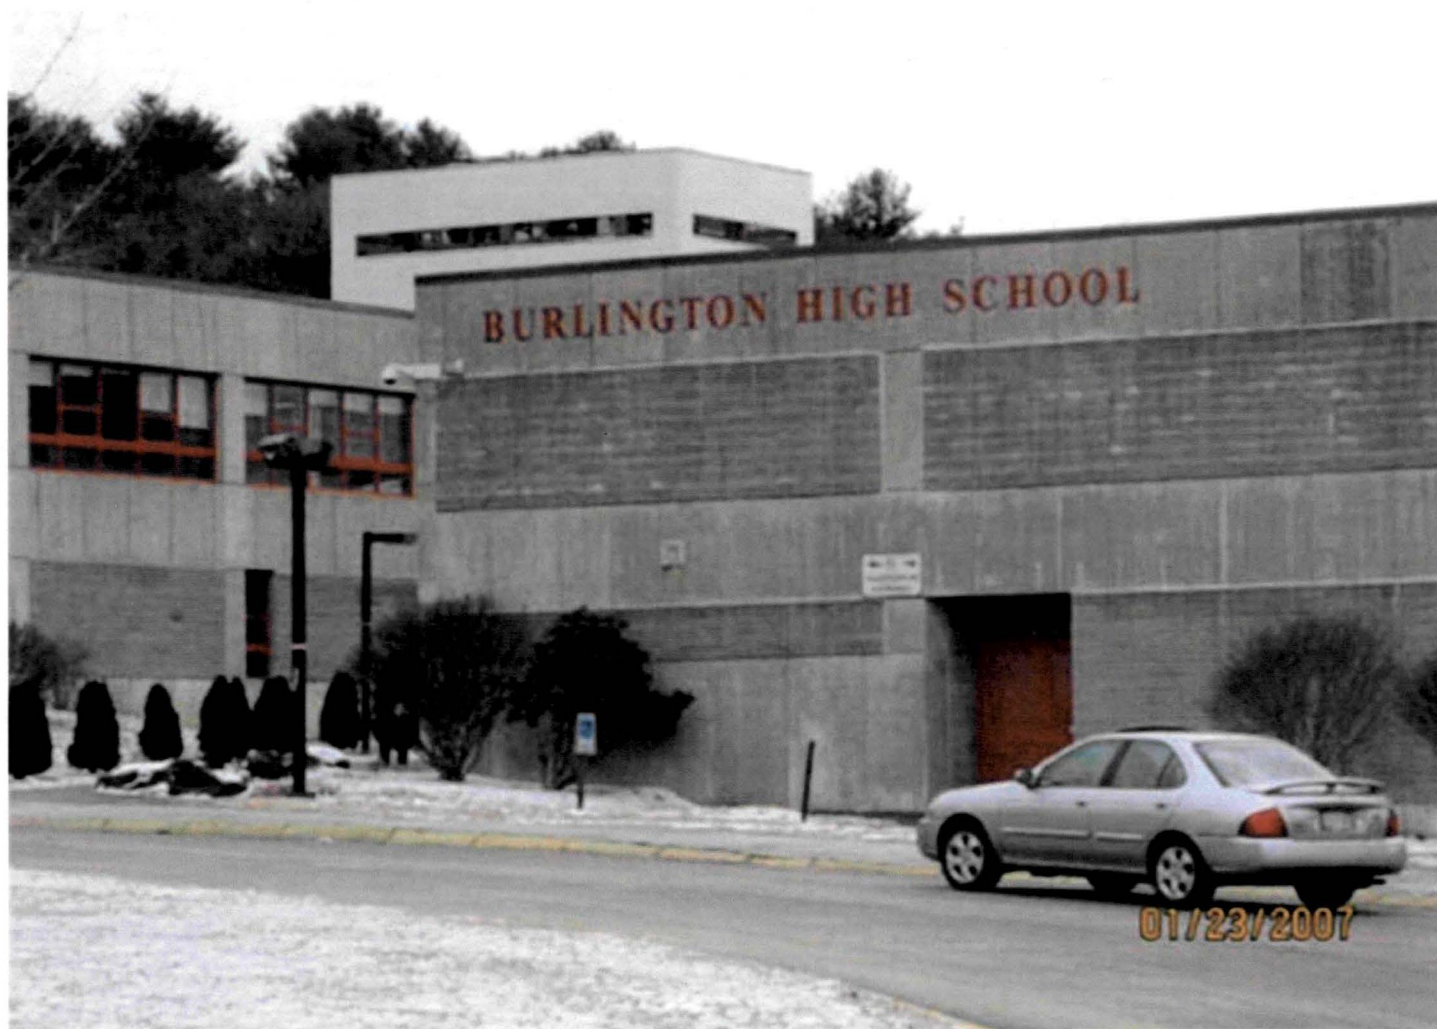
Burlington High School, Burlington, Massachusetts, 2006
Masonry Caulk 106,611ppm Arochlor 1260
